City of Alexandria Storm Sewer Capacity Analysis (CASSCA)

Four Mile Run Condition Assessment

PREPARED FOR: City of Alexandria, CH2M Hill
PREPARED BY: Baker
DATE: January 4, 2013 (Revised May 26, 2015)

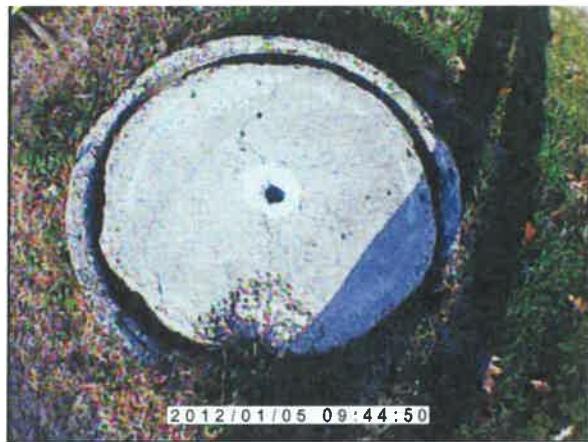
Observed defects were frequently associated with the chamber, chimney, and frame base seal components. Of the defects classified as major and extreme, most of them were still associated with the chamber, chimney, and frame base seal areas. Major damage to the chamber, for example, would be 25-50% material loss due to corrosion or pitting, a crack up to $\frac{1}{4}$ " wide, or active infiltration streaming through the wall. The manhole cover was also a common component with many major or extreme defects. Figure 4 shows an example of a badly deteriorated cover.

**Figure 4. Cover Deterioration on Structure 000104SMH
(Overall SCREAM Score = 88).**

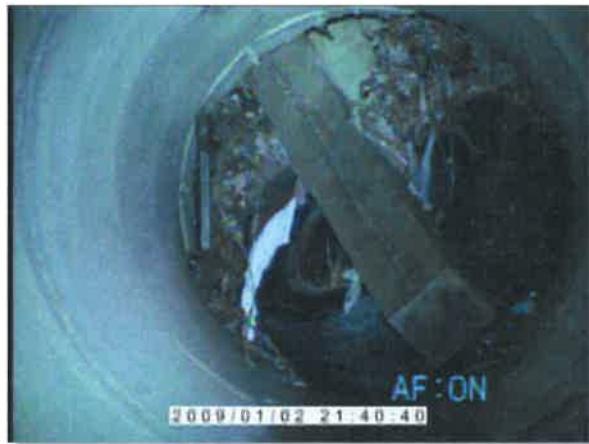
**Figure 7. Debris in 36-in Storm Pipe between Structures 000071ND and 000180SMH
(Overall SCREAM Score = 100).**

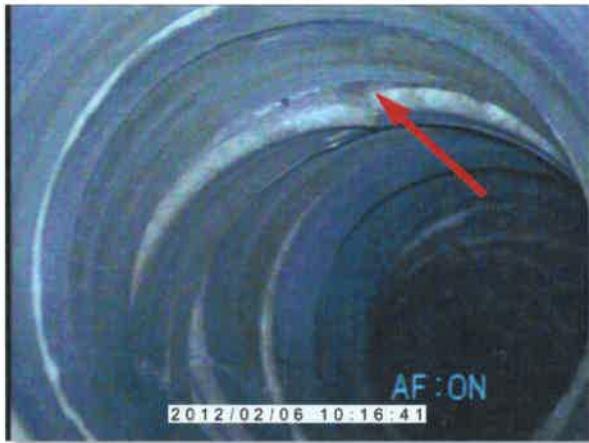
**Figure 8. Broken 24-in Storm Pipe between Structures 001481SMH and 001496SMH
(Overall SCREAM Score = 100).**
